***IN THE MATTER OF AN APPEAL OF THE CORPORATION OF THE CITY OF THUNDER  
BAY PROPERTY STANDARDS ORDER OCCURRENCE # EF:25-501648***

**KIE SHIROMA, IN HER CAPACITY AS ESTATE TRUSTEE FOR THE ESTATE OF  
NORIKO SHIROMA**

**AFFIDAVIT OF KIE SHIROMA**

**Sworn July 17, 2025**

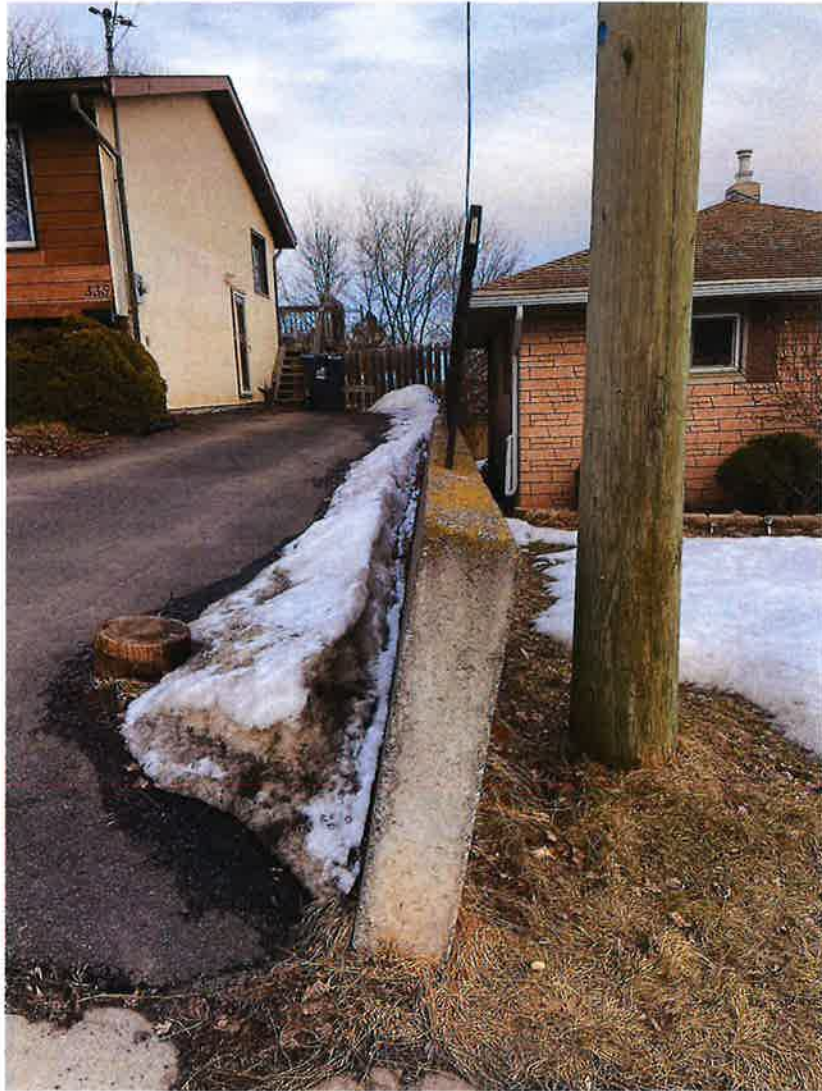
12. Attached as **“Exhibit A”** is a photo taken from the Rupert Street sidewalk showing my Property, the Neighbouring Property, and the retaining wall between them.

*Photo taken by me in March 2025 from the sidewalk of Rupert Street. My property is partially shown to the far right while the neighbouring property is shown to the far left. The retaining wall is shown in the middle.*

32. Second, by water run-off and snow accumulation from the Neighbouring Property towards the retaining wall, which may also be exacerbated in winter and spring months (see, for example, **"Exhibit A"**).

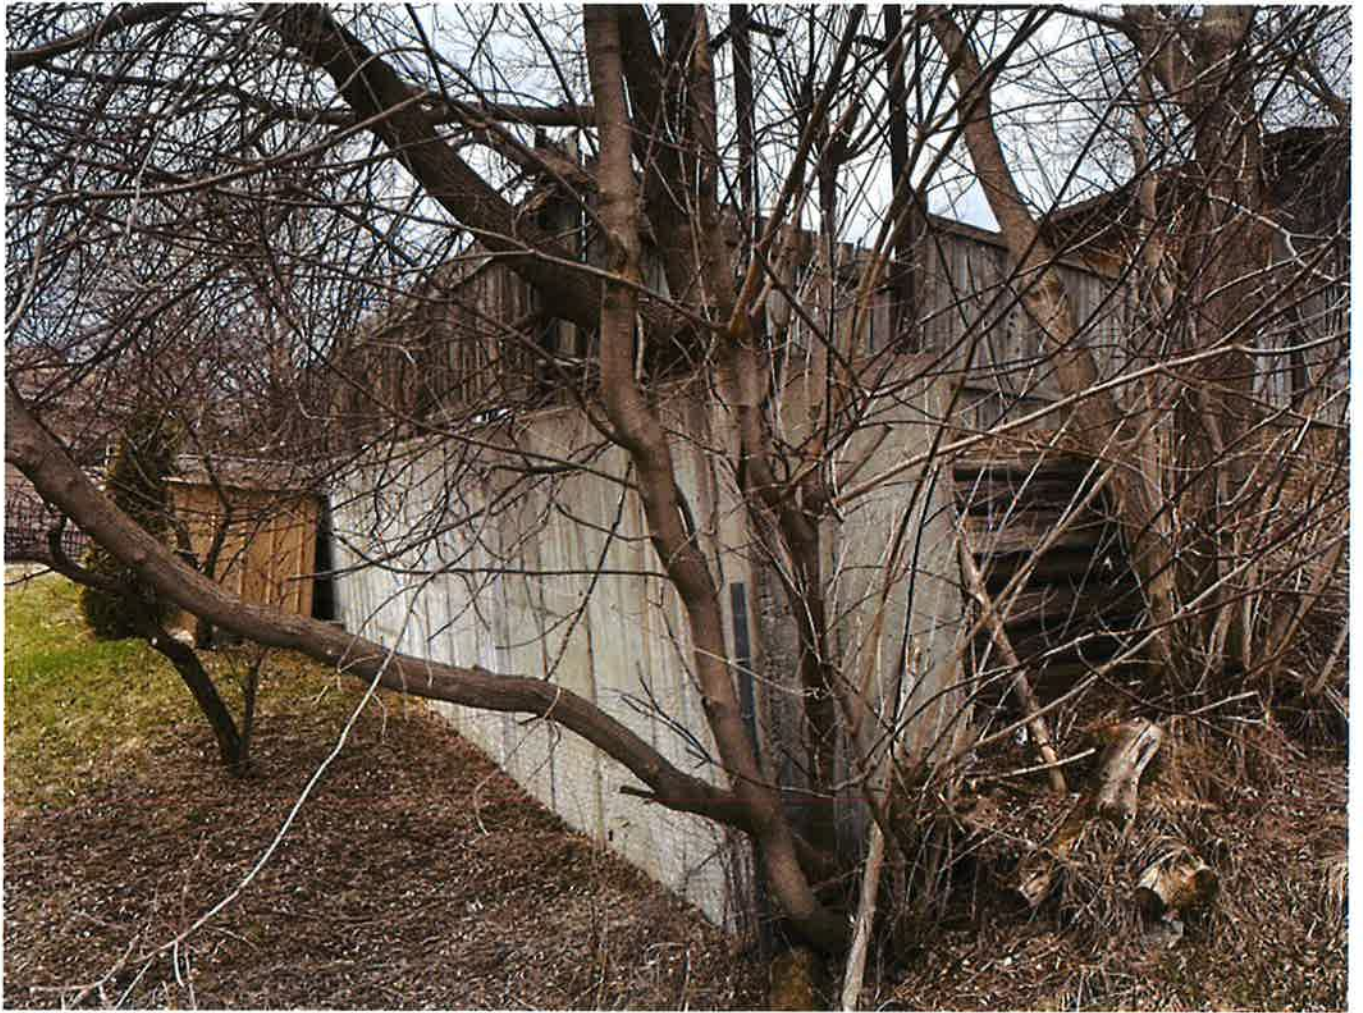
**Exhibit "B"**

17. Attached as **“Exhibit B”** is a photo taken from behind the properties showing the end of the wall and the “L” shape wrapping around the Neighbouring Property.

*Photo taken by my realtor in April 2025 from behind the properties. My property is shown to the left while the neighbouring property is shown to the upper right.*

34. Fourth, by a tree growing from underneath the retaining wall, with its roots causing structural instability and force on the wall, resulting in cracks, shifting, and displacement of the wall. This tree can be seen in **"Exhibit B"**.

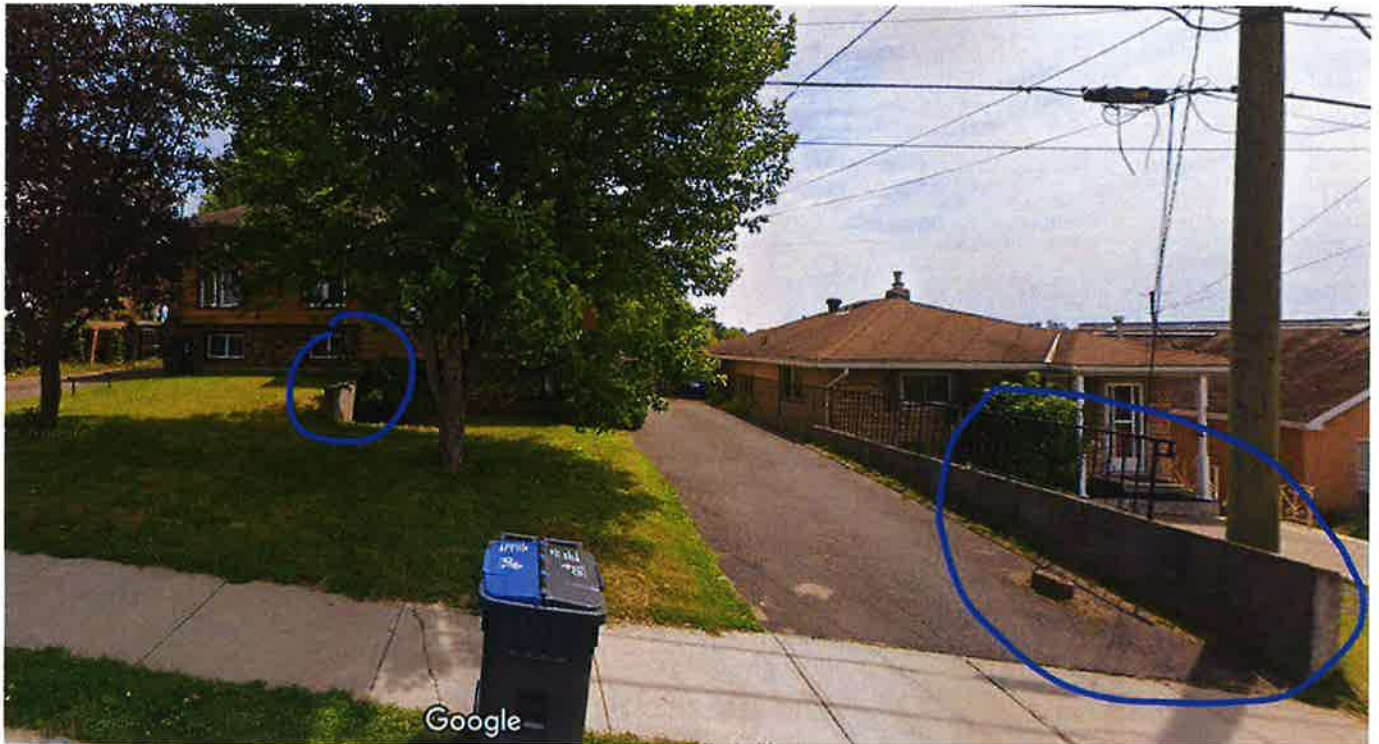
**Exhibit "C"**

23. First, the retaining wall between the properties is similar in appearance to a smaller retaining wall at the front of the Neighbouring Property. The other retaining wall can be seen in the photo attached as “**Exhibit C**” roughly halfway between the Neighbouring Property and its neighbouring property.

*A screenshot taken from Google Street View in June 2025. Original image captured in July 2024. The smaller retaining wall is shown to the centre left of the photo, while the retaining wall that is the subject of the Order is shown to the right. I have added the blue circles.*
