**SUBJECT: PART IV DESIGNATION UNDER THE ONTARIO HERITAGE  
ACT OF 27 CUMBERLAND STREET SOUTH**

**Heritage Property Designations  
27 Cumberland Street South**

Egis Project #: CCO-26-2372-00

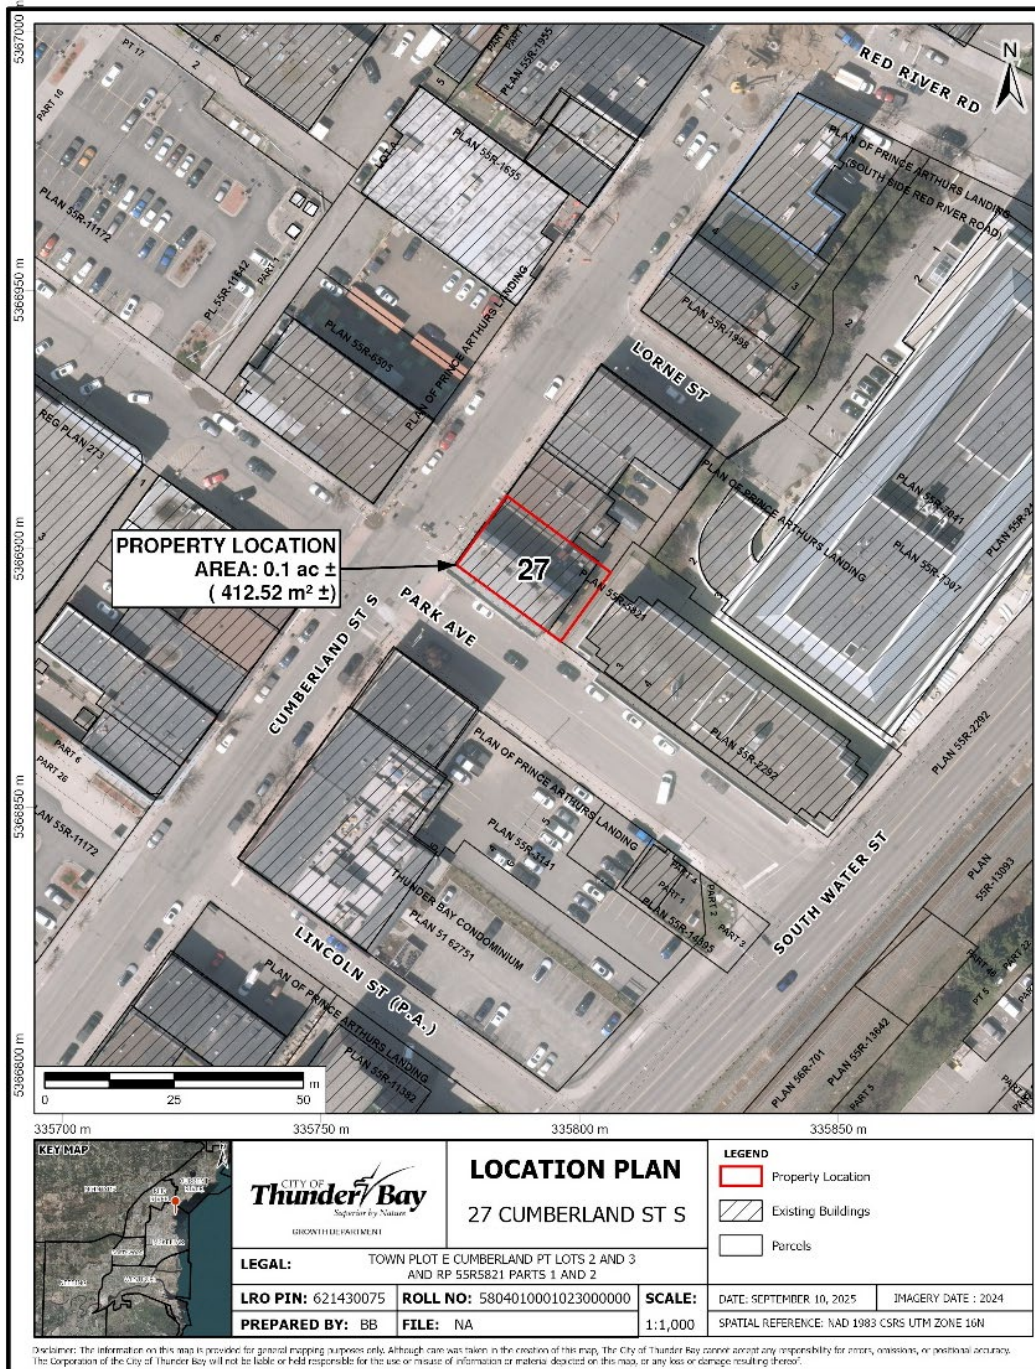
**Figure 1: Building location within 27 Cumberland Street South, City of Thunder Bay, Ontario**

The location map shows the boundary of the property at 27 Cumberland Street South and the existing buildings within the property (**Figure 1**, below).

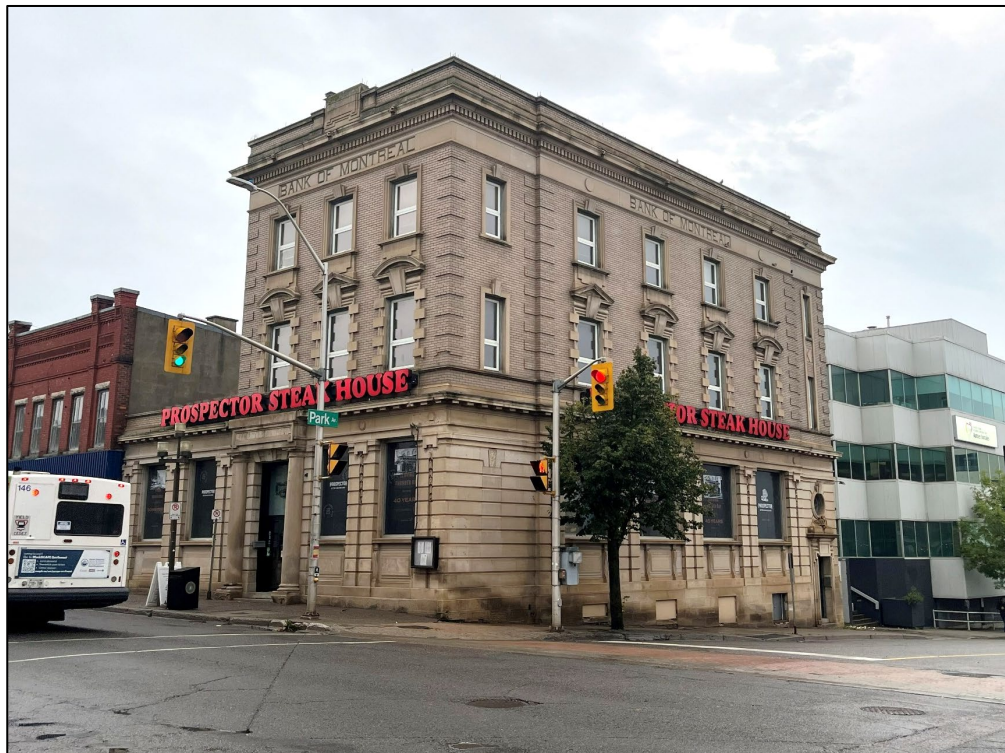
**Photograph 1:** West (former bank entrance) and south (former office/residential entrance) elevations of the former bank building (Source: Egis, October 17, 2025).

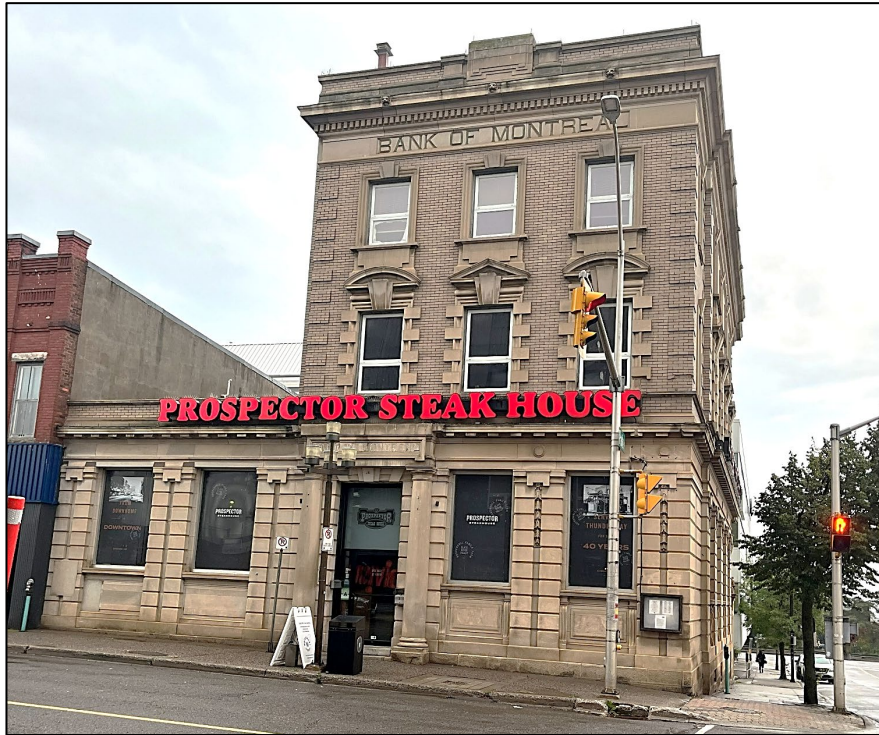
**Photograph 2:** West elevation (former bank entrance) of the building (Source: Egis, October 17, 2025).

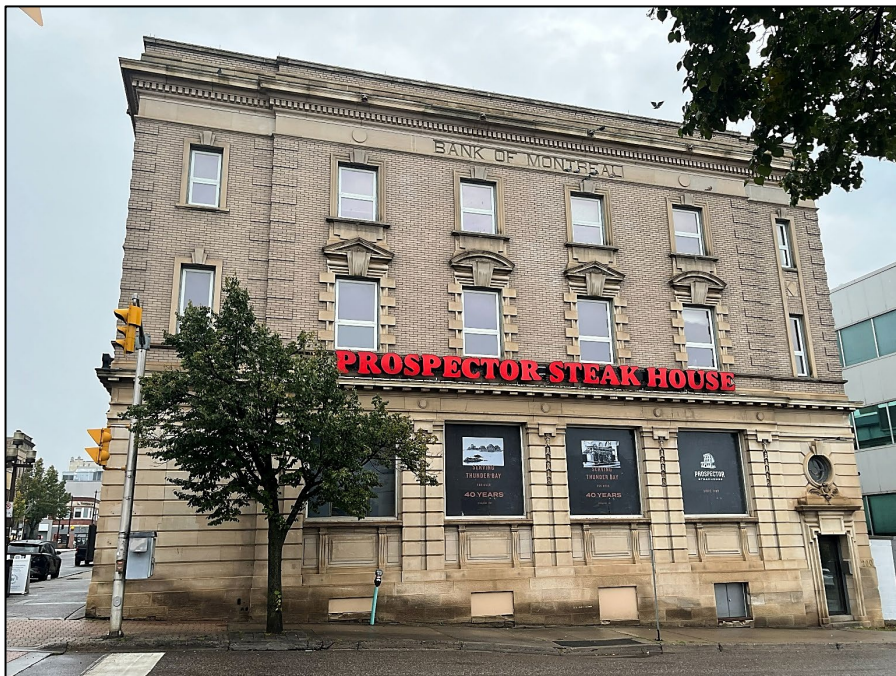
**Photograph 3:** South elevation (former entrance to the upper-level offices and residence) of the building (Source: Egis, October 17, 2025).

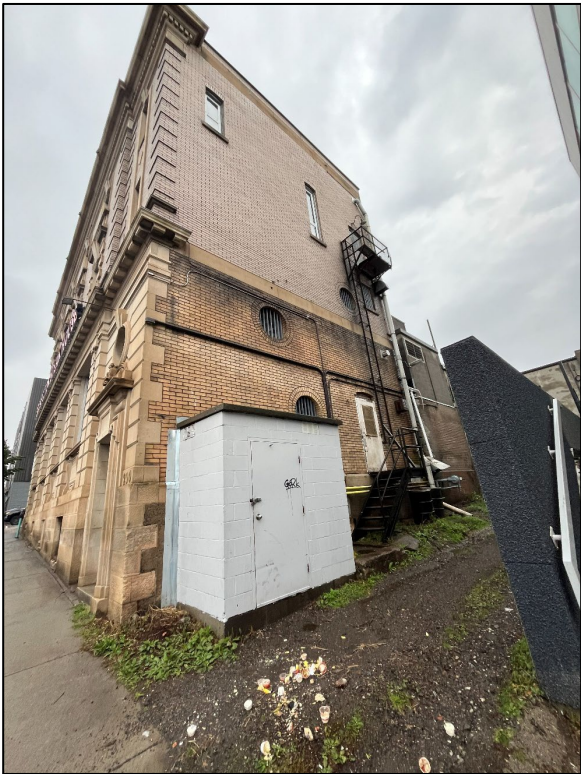
**Photograph 4:** East elevation (rear) of the building (Source: Egis, October 17, 2025).

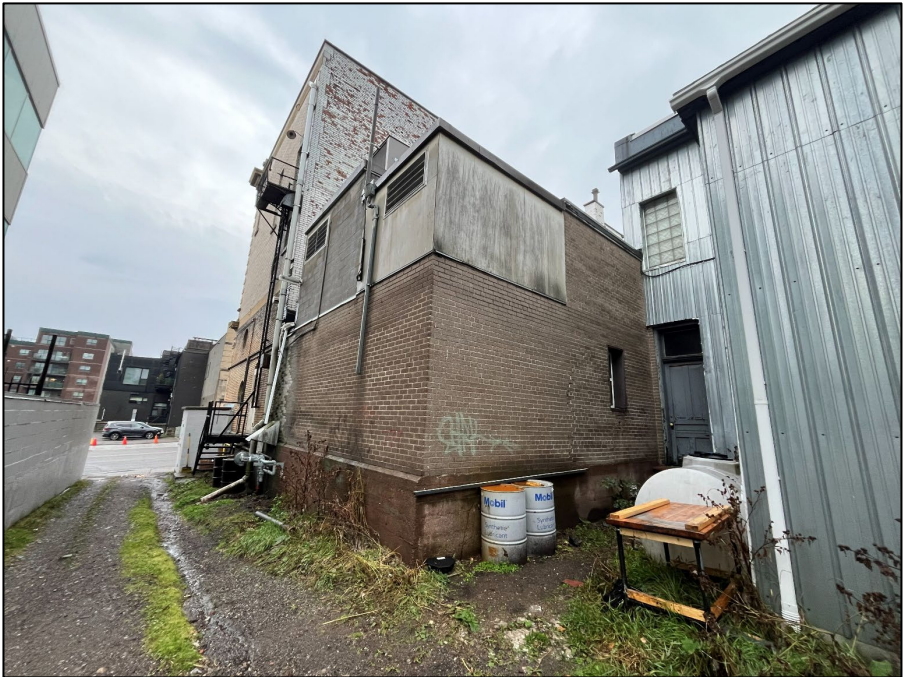
**Photograph 5:** East and north elevations of the rear of the building (Source: Egis, October 17, 2025).

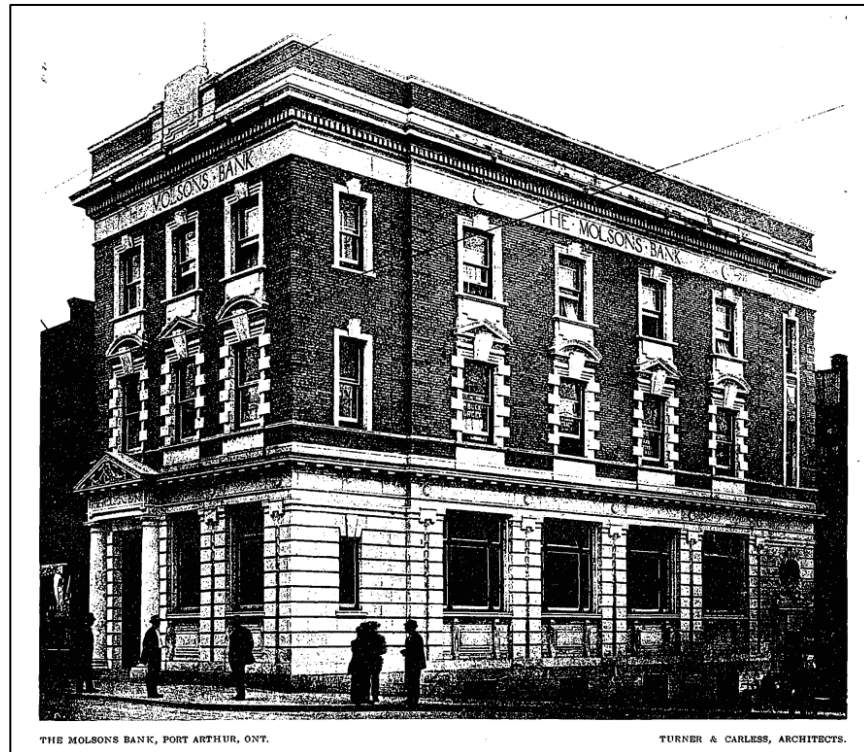
Image 1: 1916 photograph of The Molsons Bank in Port Arthur, Turner & Carless Architects  
(Source: Turner, 1916)

<sup>5</sup> As shown in Image 1, below, the previous inscription was *The Molsons Bank* before the Bank of Montreal purchased the bank in 1925.

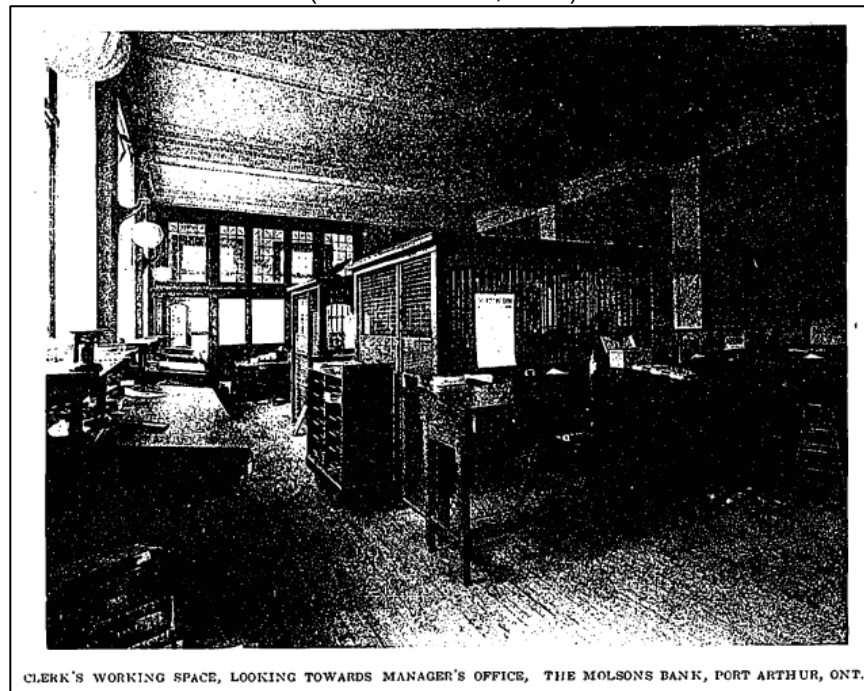
Image 2: Original Interior View of The Molsons Bank in Port Arthur in 1916 (Source: Turner, 1916)

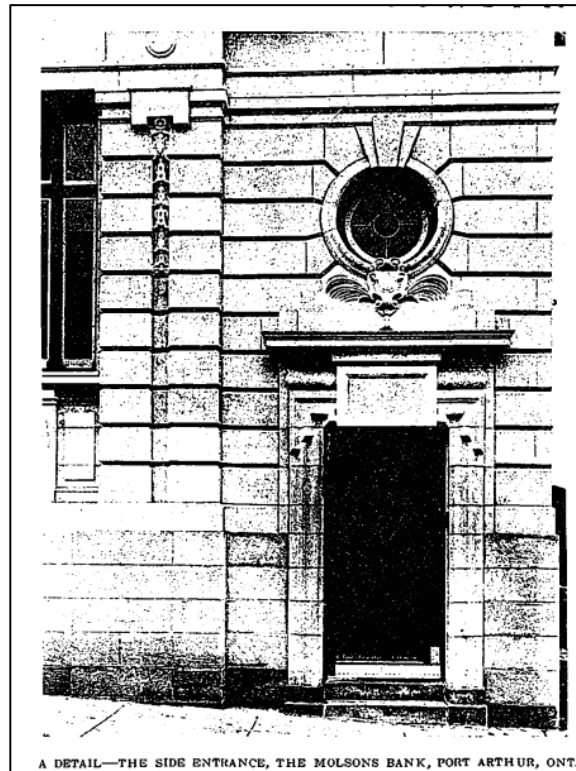
**Image 4:** Side Entrance on Park Avenue of The Molsons Bank, Port Arthur, in 1916  
(Source: Turner, 1916)

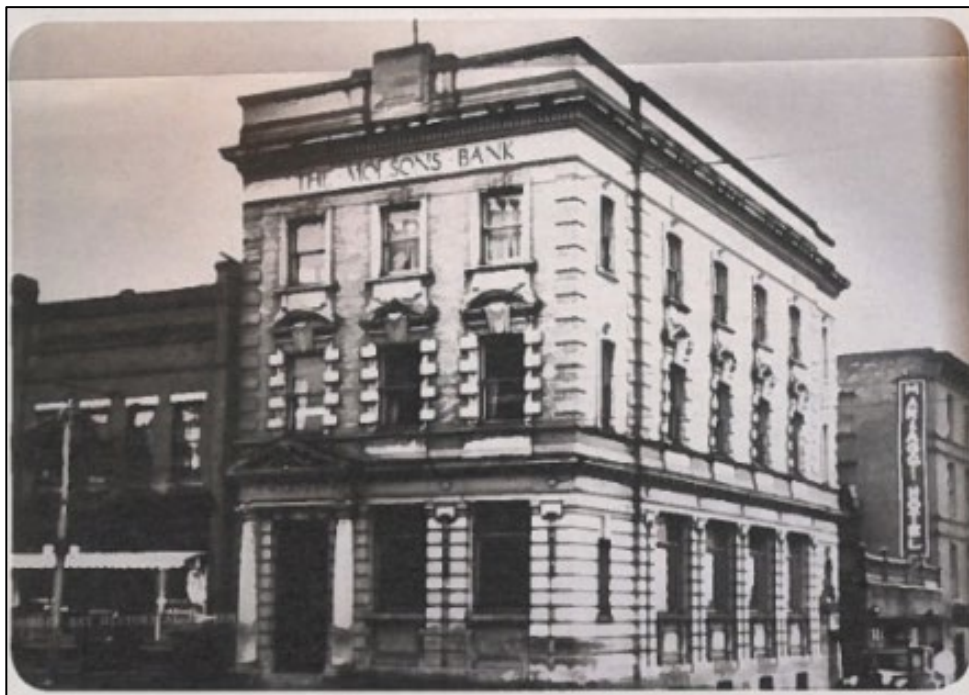
**Image 5:** View of The Molsons Bank prior to the one-storey north addition (prior to November 1925)  
(Source: Pamela Cain. "27 Cumberland Street South: Bank's Investment Renews Prospects for the Future." *The Walleye*, February 2017)

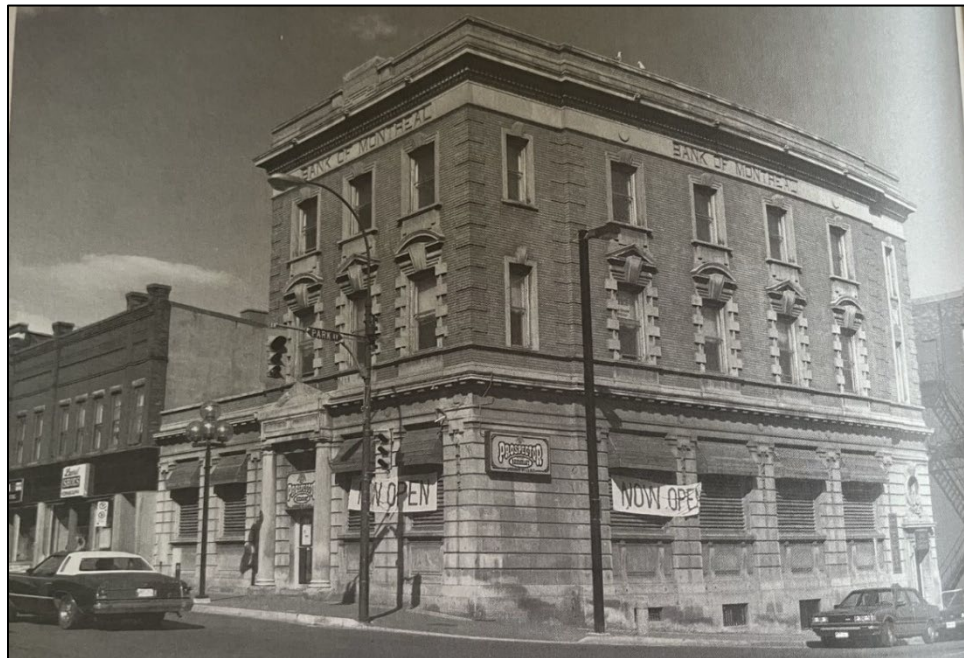
**Image 7:** Edwardian Classicism building as featured in *Ontario Architecture* by John Blumenson, view in ca. 1990 (Source: Blumenson, 1990:168)

In his 1990 publication *Ontario Architecture: A Guide to Styles and Building Terms, 1784 to the Present*, John Blumenson features the building at 27 Cumberland Street South as an example of Edwardian Classicism, which incorporated some features of 16<sup>th</sup> century Italian Mannerism into its design. These features include the stone banding along the ground-storey exterior walls, the compound window pediments alternating between segmentally arched and triangular forms, moulded surrounds framing the recessed rectangular window openings, multiple prominent keystones, and an office entrance with an enriched oculus window at the mezzanine level.<sup>4</sup> Other Classical-inspired architectural features that contribute to the building's sophisticated design and showcase the use of premium masonry materials include a parapet with raised central panel on the front (west) elevation, decorative cornice with lion head spouts, dentils, and frieze with the inscription *The Bank of Montreal* carved in stone;<sup>5</sup> brick quoins; a substantial stone cornice with modillions between the first and second storeys; ground-floor windows with heavy stone sills supported by scrolled brackets and moulded panels beneath; and a series of floral relief ornaments with their petals extending downward between the stone banding of the ground floor. The main bank entrance is on Cumberland Street and features Doric-style pilasters on either side of the recessed entrance supporting a smaller frieze with a second *Bank of Montreal* inscription.
